REQUEST FOR BIDS
ASBESTOS PROJECT DESIGN, ABATEMENT & AIR MONITORING
ITB# 22-24/25
September 12, 2024

Emerald, Inc. was requested to conduct an Asbestos Survey of the vacant, significantly collapsed, commercial structure located at 5 Harris St. in Sumter, S.C., to identify the presence of any asbestos-containing materials (ACM), prior to demolition activities. The inspection was authorized by Mr. John Macloskie, Codes Director, with the City of Sumter. The inspection included identification and assessment of the condition of suspect asbestos-containing materials, either friable or non-friable, on the interior and exterior portions of the structure.

**Sumter City/County Project:
Dilapidated Commercial Bldg.
5 Harris St., Sumter, SC
-Site Layout**

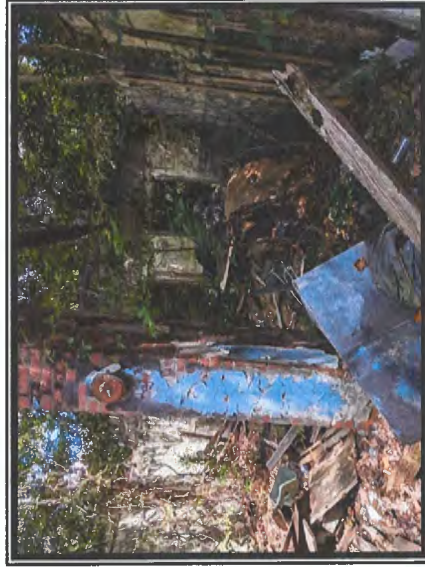
Photo #3
Interior View of East Section Depicting
Significantly Dilapidated Building Conditions

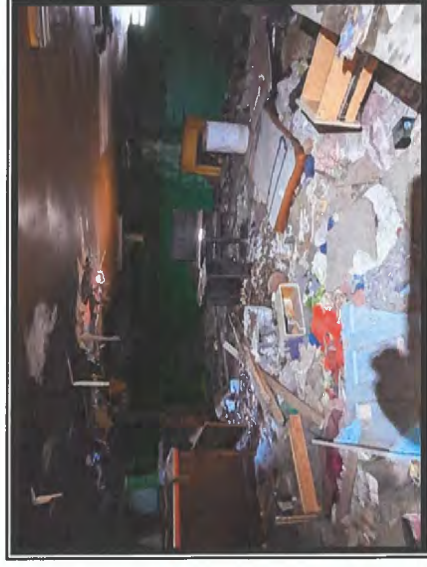
Photo #8
View Depicting Dilapidated Interior Conditions in the West Section

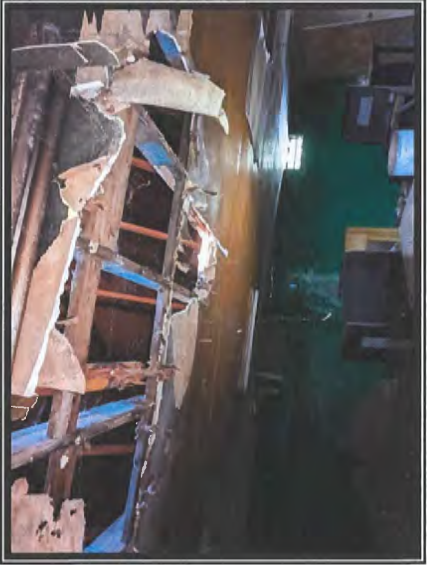
Photo #9
No Asbestos Detected in Sheetrock System of
the West Section

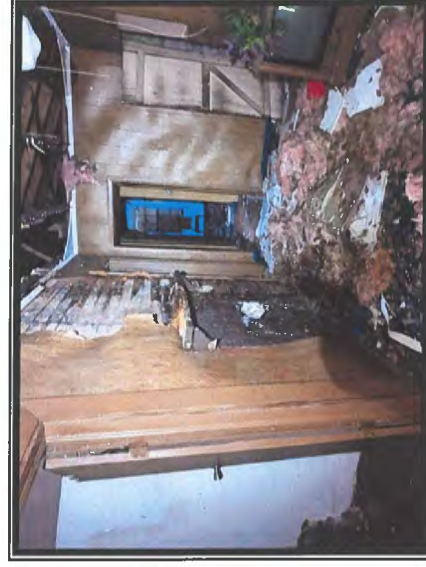
Photo #4
View Depicting Dilapidated Building Conditions

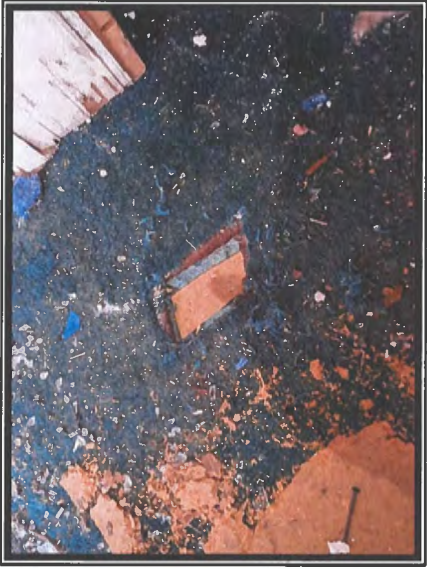
Photo #5
No Asbestos Detected in Any Floor Covering
Layers

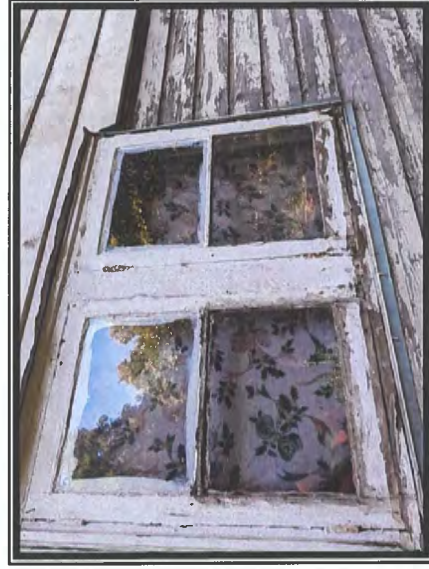
Photo #7
Asbestos Detected at <0.1% in Window Glaze,
via TEM Analysis

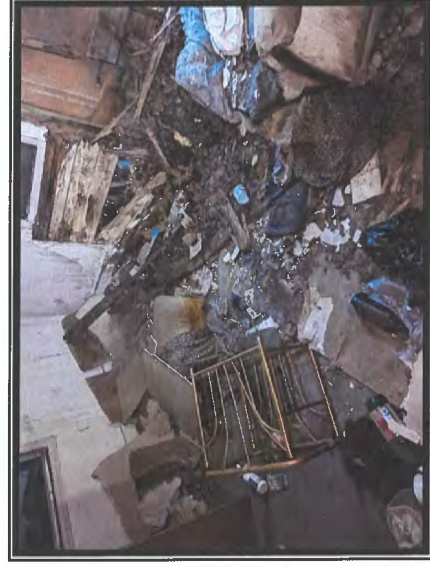
Photo #8
Asbestos-containing Sheetrock Wall & Ceiling Debris Scattered in Room 22B

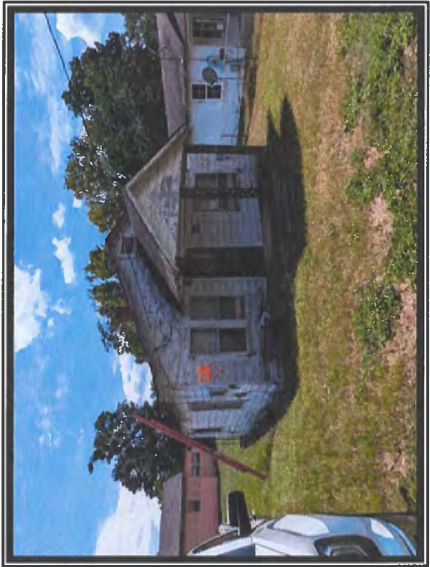
Photo #1
View Depicting the Front of the Residential Structure

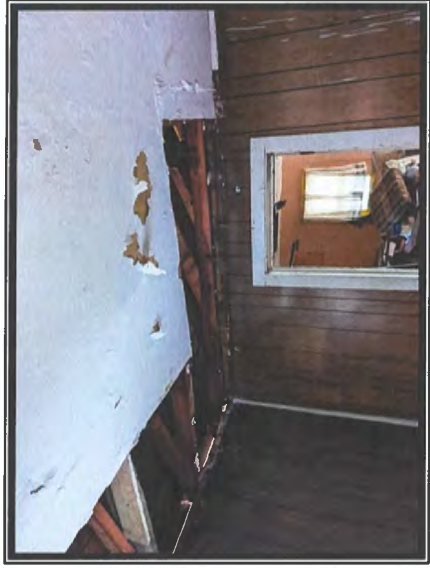
Photo #2
Asbestos Detected at 3% in Sheetrock Ceiling System

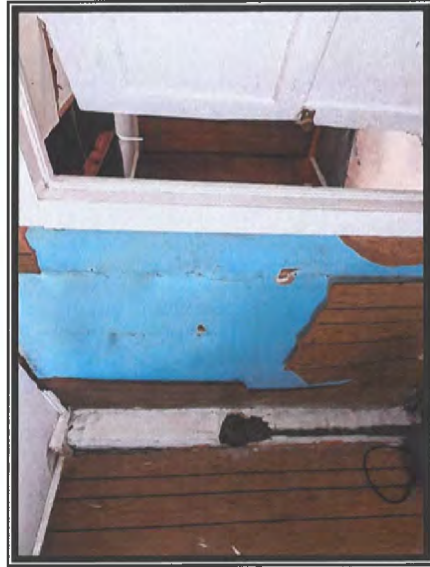
Photo #3
View Depicting Asbestos-containing Sheetrock Wall behind Wall Paneling

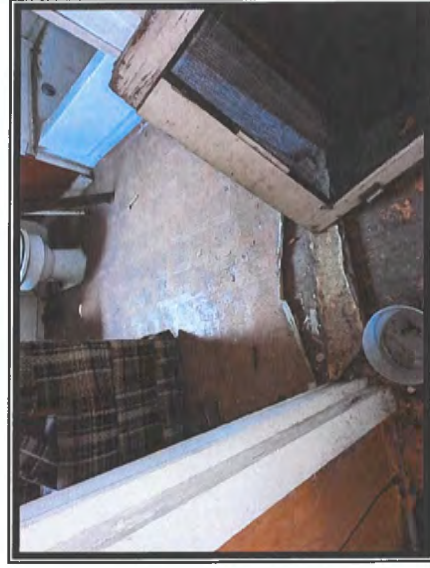
Photo #4
No Asbestos Detected in Wood-design Sheet Flooring

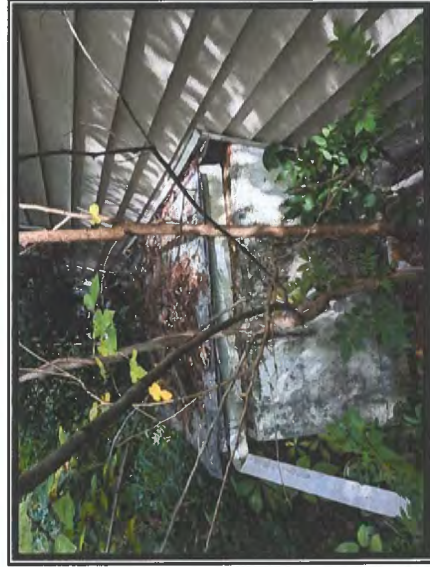
Photo #3

No Asbestos Detected in Pump House Roofing Materials

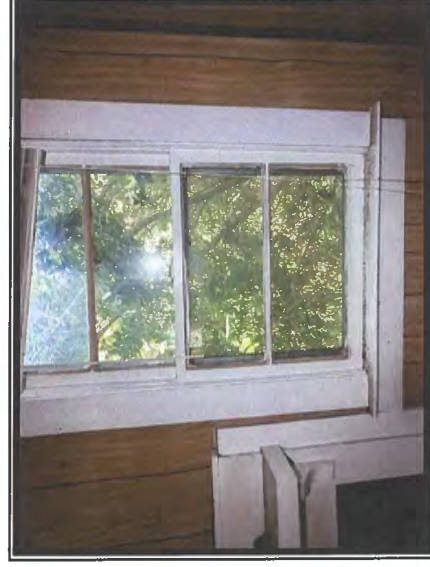
Photo #4

View Depicting a Divided Light-type Window Sash with Glaze (<1% Asbestos)

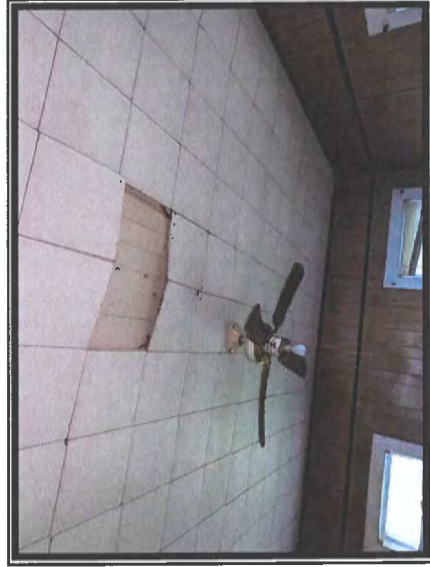
Photo #7
No Asbestos Detected in Cellulose-based
Ceiling Tiles in Room 112B

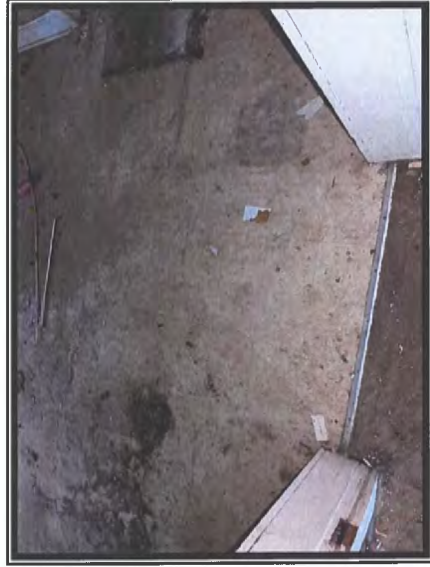
Photo #11
No Asbestos Detected in Tan Square-design
Sheet Flooring

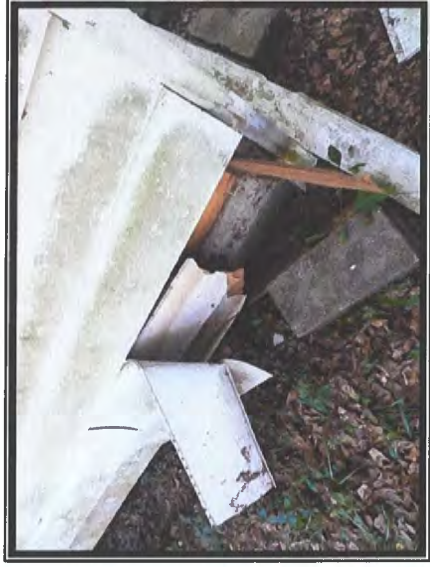
Photo #2
No Asbestos Detected in Exterior Fiberboard
Wall Panels or Sheathing Board

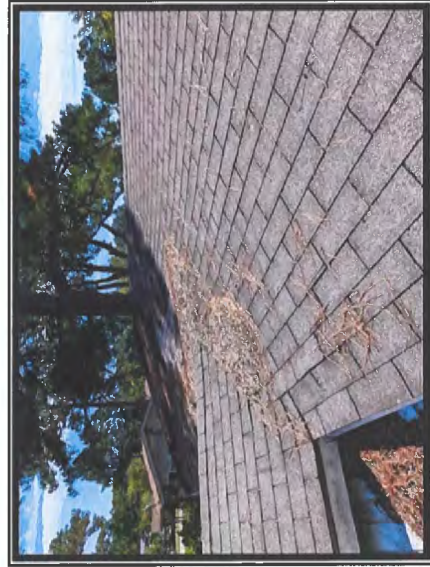
Photo #3
No Asbestos Detected in Residential Roofing
Shingles or Felt Layer

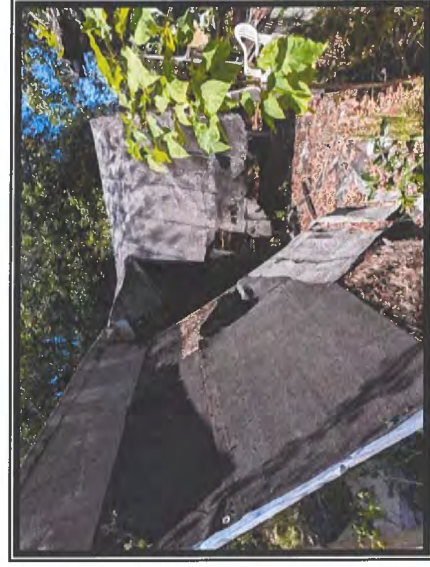
Photo #4
No Asbestos Detected in Shingle Rolls of the
Wooden Shed Structure

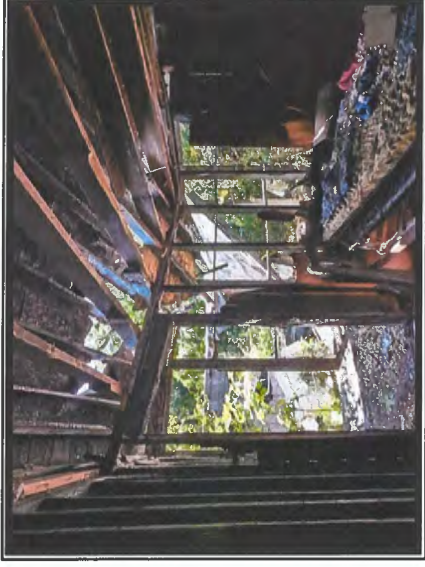
Photo #6
View Depicting Significant Fire Damage to Building Materials in Room 308F

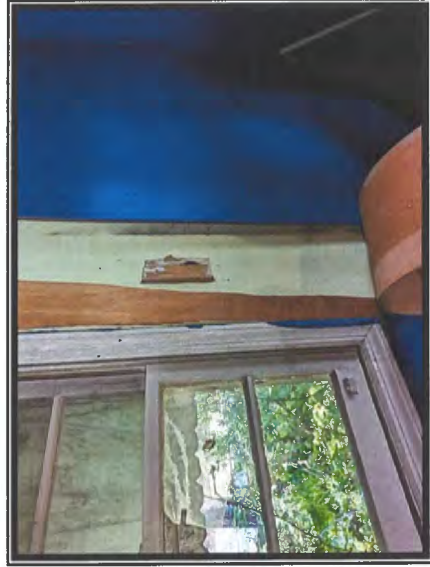
Photo #7
Asbestos-containing Sheetrock Wall behind Wall Paneling in Room 308A

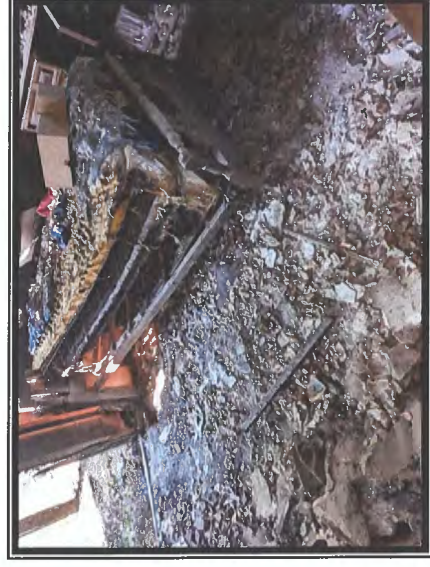
Photo #8
Asbestos-containing Ceiling Debris on Floor in Room 308F

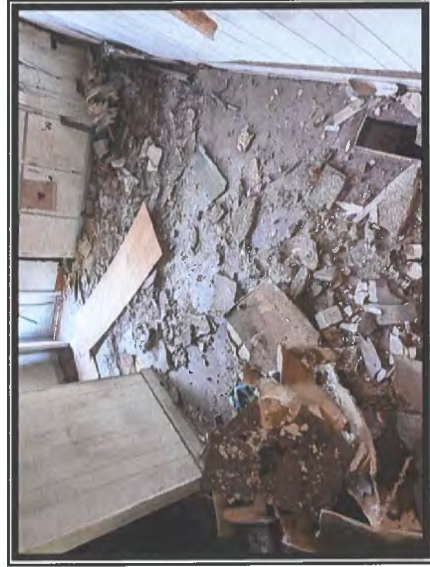
Photo #11
Asbestos-containing Sheetrock Ceiling Debris on Floor of Room 308E

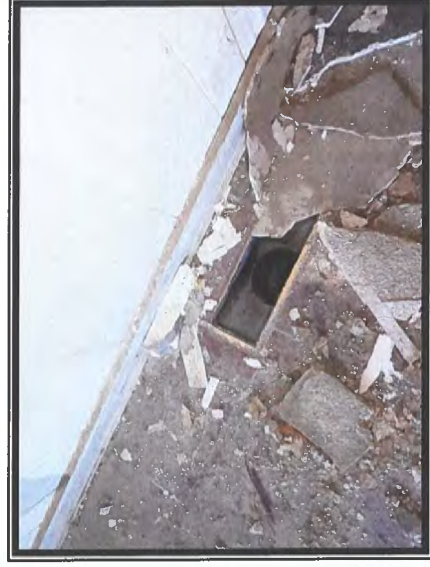
Photo #12
No Asbestos Detected in Duct Tape Associated with Vent and Crawl Space Ductwork

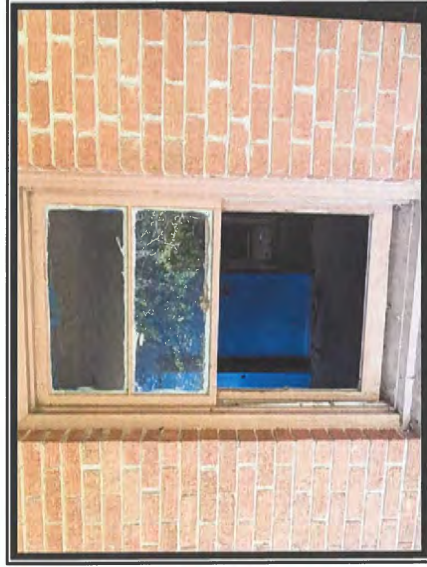
Photo #3
No Asbestos Detected in Glaze or Caulk Associated with Window Units

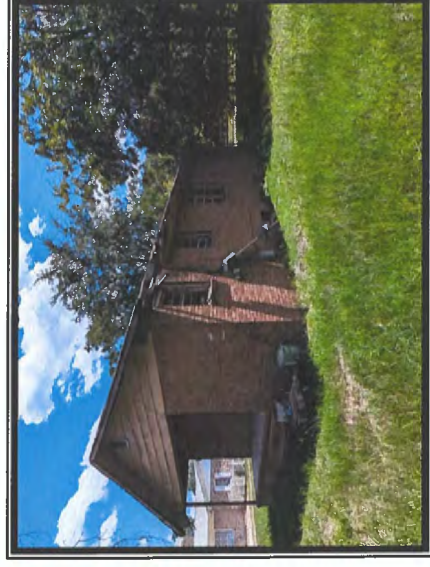
Photo #8
Southeast-facing View Depicting Damage to
Roof Components

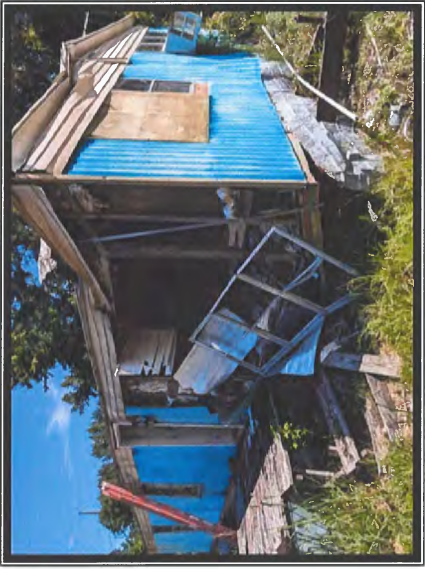
Photo #1
North-facing View Depicting the Damaged
Condition of the Mobile Home

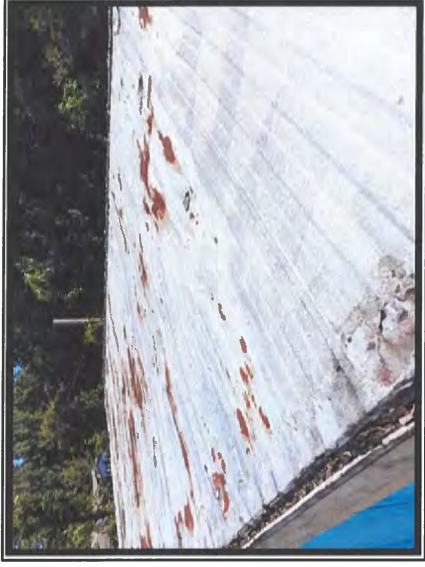
Photo #2
Asbestos Detected at 5% in Silver Roof
Sealant Material
