REQUEST FOR BIDS
ASBESTOS PROJECT DESIGN, ABATEMENT & AIR MONITORING
ITB# 22-24/25
September 12, 2024

Emerald, Inc. was requested to conduct an Asbestos Survey of the vacant, significantly collapsed, commercial structure located at 5 Harris St. in Sumter, S.C., to identify the presence of any asbestos-containing materials (ACM), prior to demolition activities. The inspection was authorized by Mr. John Macloskie, Codes Director, with the City of Sumter. The inspection included identification and assessment of the condition of suspect asbestos-containing materials, either friable or non-friable, on the interior and exterior portions of the structure.

**Sumter City/County Project:
Dilapidated Commercial Bldg.
5 Harris St., Sumter, SC
-Site Layout**

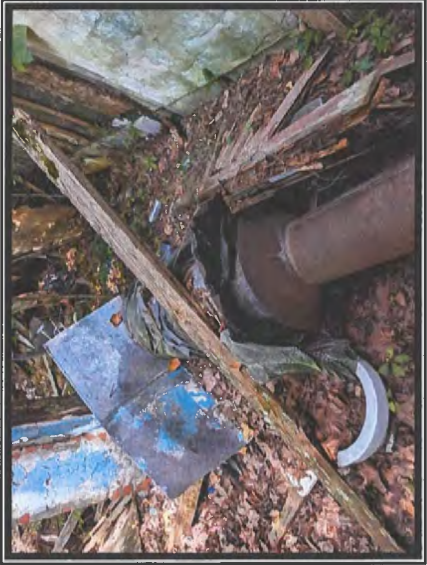
Photo #5
Asbestos-containing Roof Penetration Sealant Material in Debris of East Section

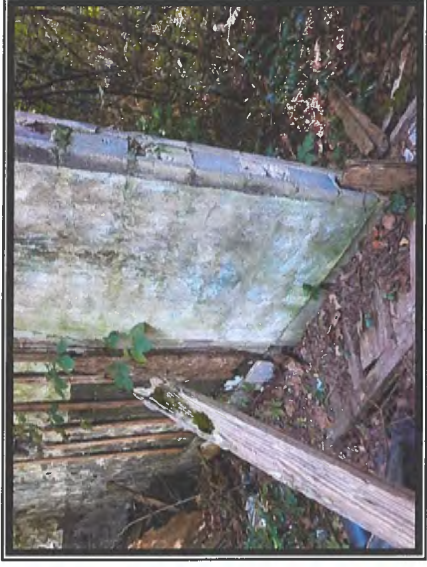
Photo #6
Remnant Areas of Asbestos-containing Wall Materials in East Section

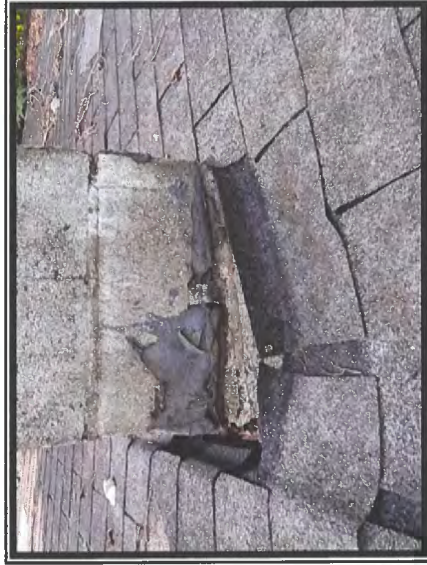
Photo #11
No Asbestos Detected in Chimney Flashing
Sealant of the West Section

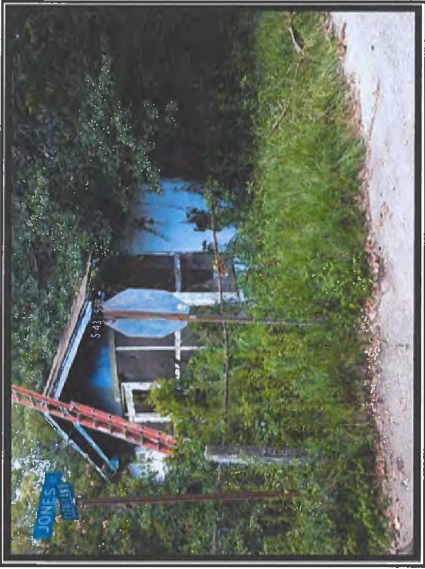
Photo #1
West-facing View Depicting the Front of the Residential Structure

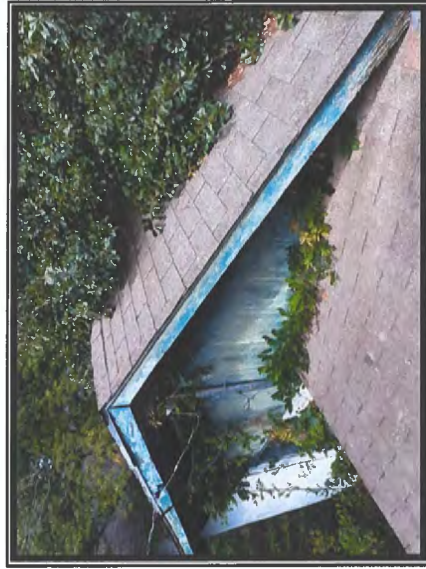
Photo #3
View Depicting Roof Area: Dark Gray Sealant at Chimney & Seams Contains Asbestos

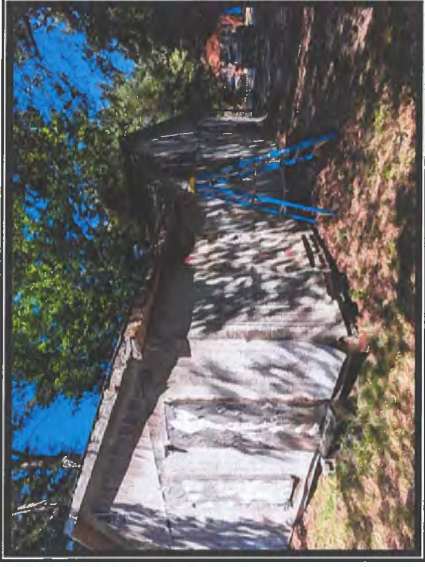
Photo #2
Northwest-facing View Depicting the Additional Rear Section to the Original Structure

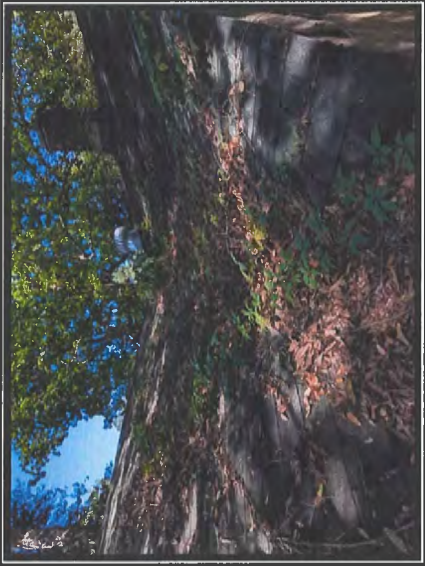
Photo #5
No Asbestos Detected in Roofing Shingles or Felt Layer

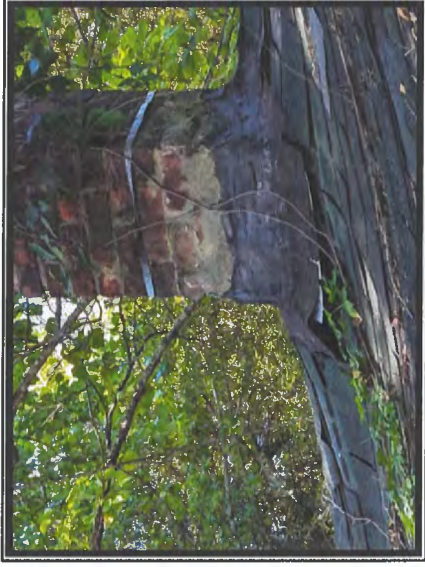
(1) - Chimney flashing was observed but could not be accessed, due to hazardous roof conditions; therefore, the flashing material is PACM.

Photo #6
Chimney Flashing Sealant is Presumed to Contain Asbestos (PACM)

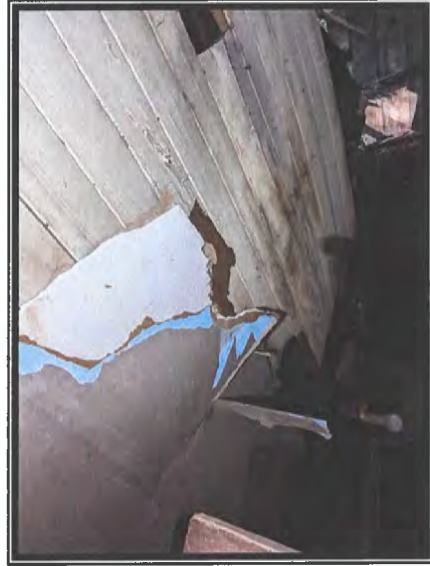
Photo #7
Asbestos Detected at 4% in Sheetrock System of Original House Footprint

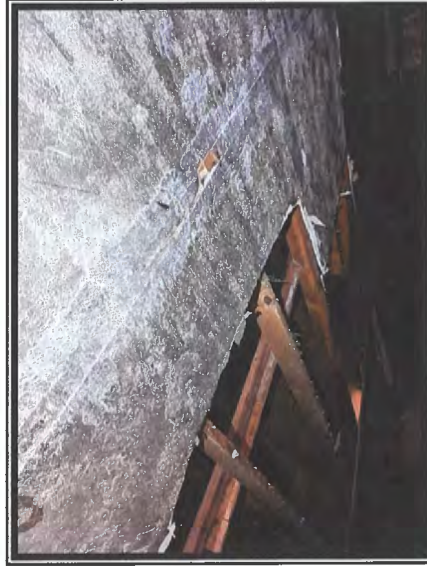
Photo #11
No Asbestos Detected in the Sheetrock Ceiling or Textured Material in the Addition Section

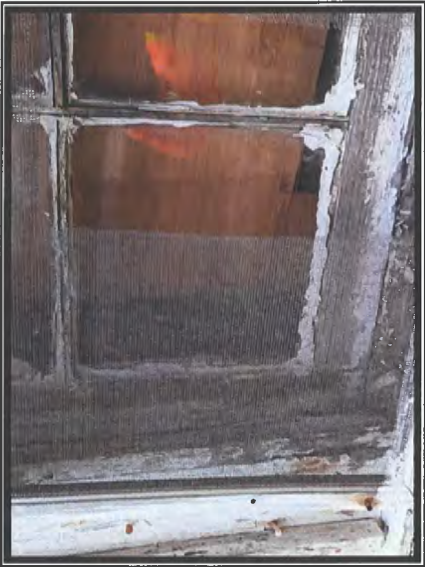
Photo #5
<1% Asbestos Detected in Window Glaze

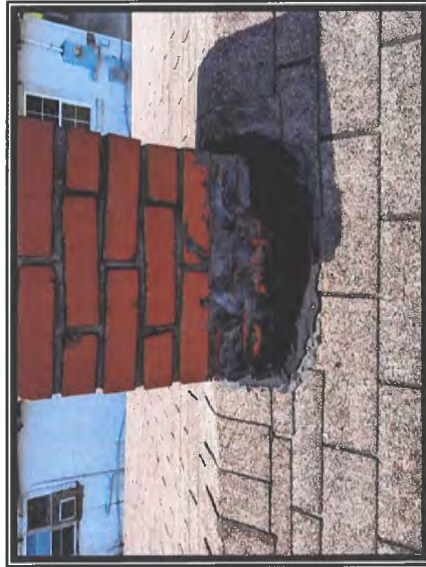
Photo #7
Asbestos Detected at 6% in Chimney Flashing Sealant

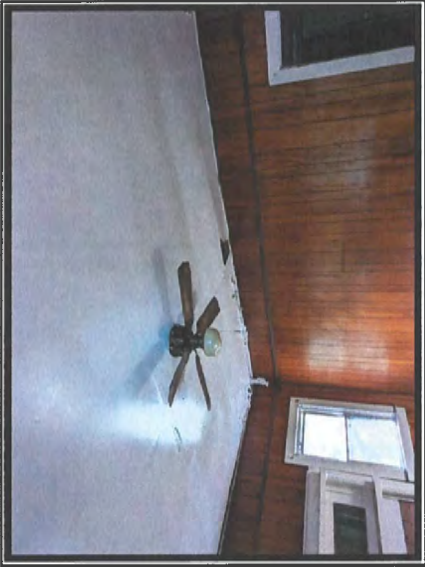
Photo #5
Asbestos Detected at 3% in Sheetrock
Ceiling System, as Seen in Room 112A

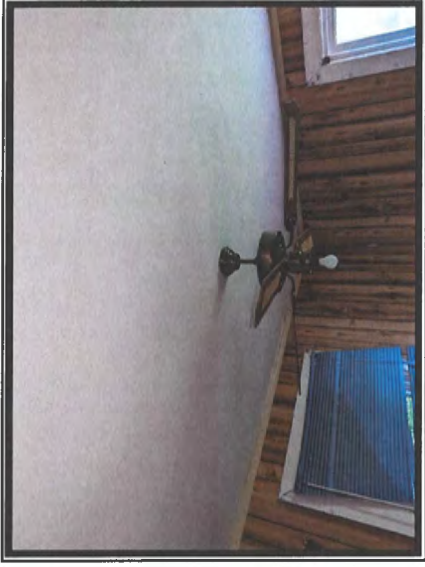
Photo #6
Asbestos-containing Sheetrock Ceiling in
Room 112D

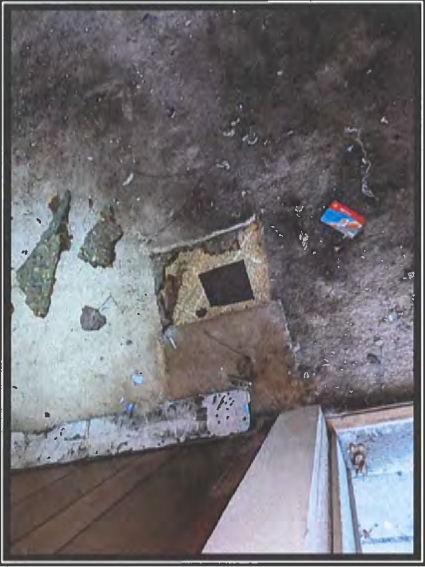
Photo #9
No Asbestos Detected in Tan Weave-design
Sheet Flooring under Carpet

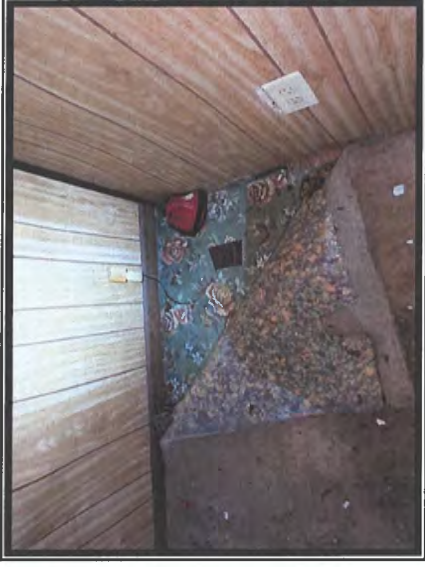
Photo #10
No Asbestos Detected in Green Floral-design
Sheet Flooring under Carpet

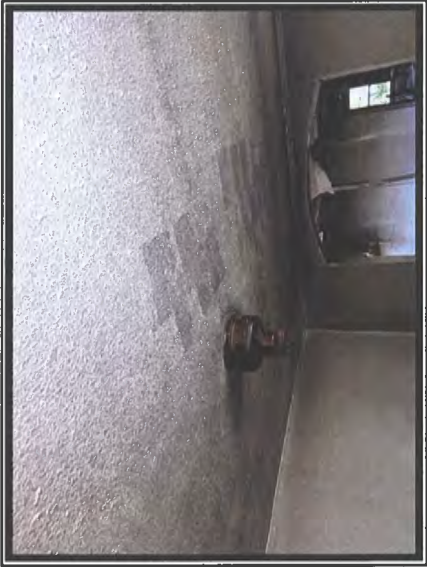
Photo #9
No Asbestos Detected in Spray-applied Ceiling Texture (Sheetrock is RACM)

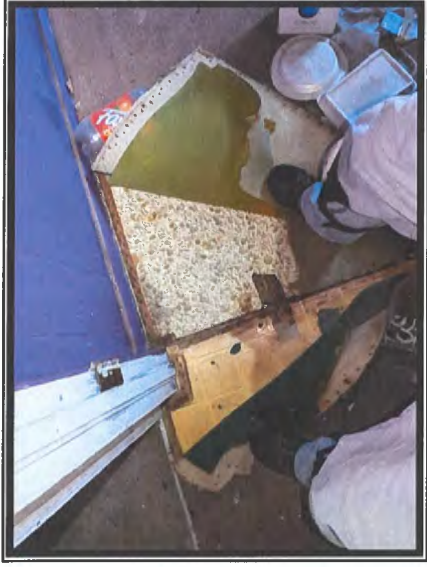
Photo #10
No Asbestos Detected in Any Sheet Flooring or Carpet Layers

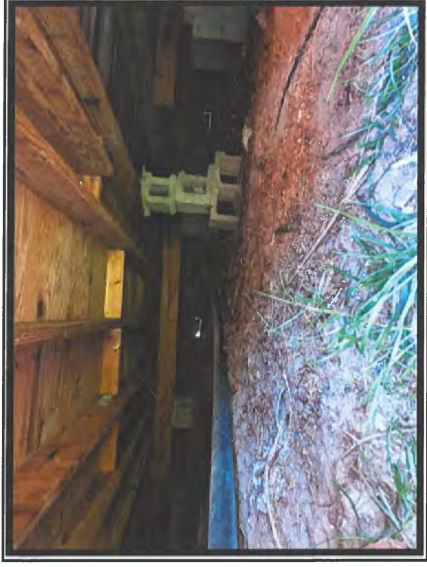
Photo #2
No Suspect Materials Observed in Earthen Crawl Space Area

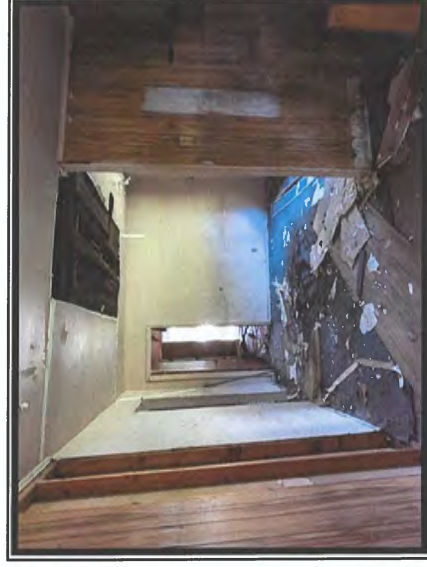
Photo #4
View Depicting Dilapidated Interior Conditions

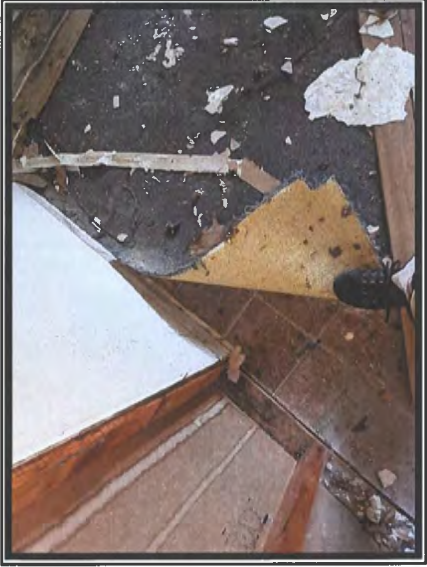
Photo #5
No Asbestos Detected in Carpet or Sheet
Flooring Materials

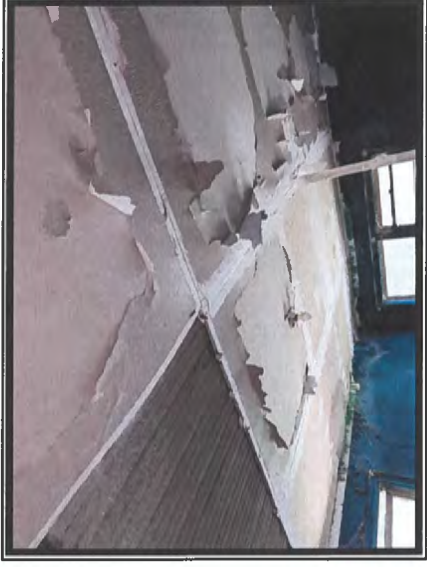
Photo #6
No Asbestos Detected in Ceiling Sheetrock or
Stippled Texture

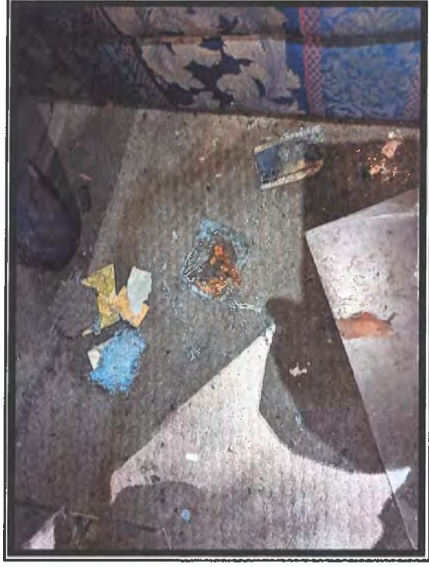
Photo #6
No Asbestos Detected in Carpet Layers

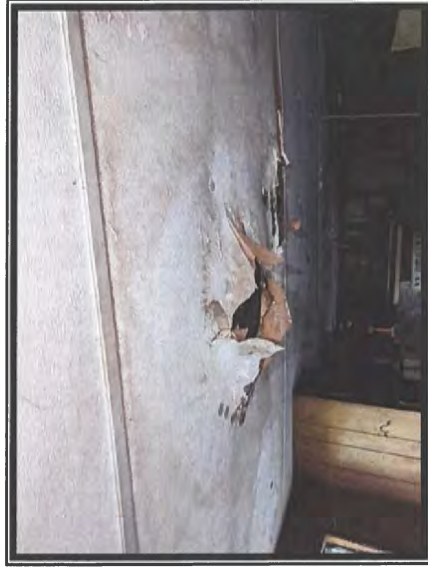
Photo #7
No Asbestos Detected in Gypsum Ceiling
Panels

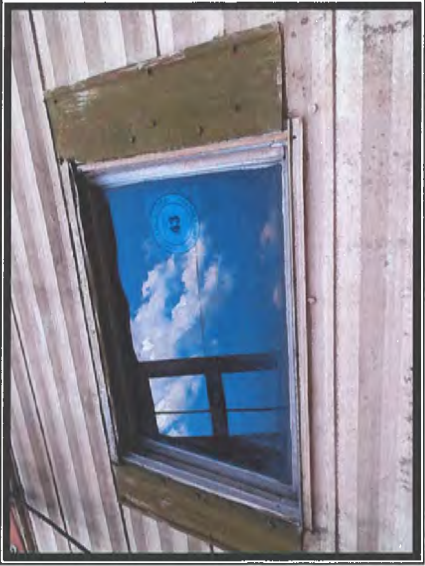
Photo #5
Asbestos Detected at 5% in Tan-colored
Window Frame Sealant Material

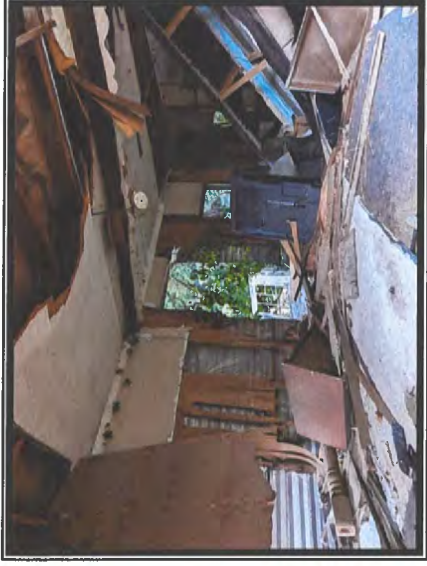
Photo #10
View Depicting Dilapidated State of the Mobile Home's Interior

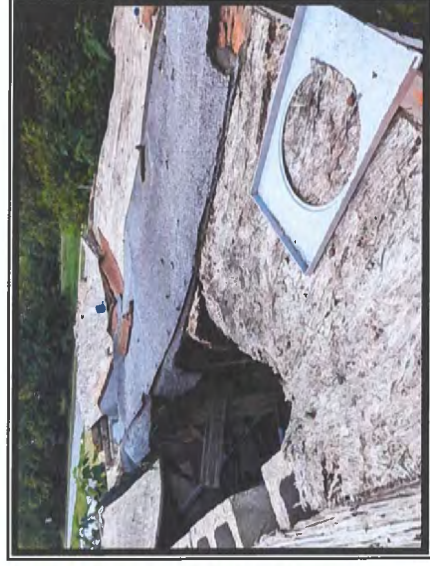
Photo #12
No Asbestos Detected in Roofing Layers Associated with the Block Storage Building

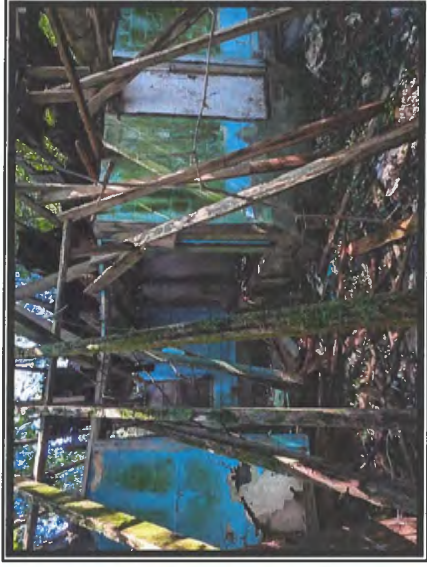
Photo #2
View Depicting the Collapsed Roof Structure

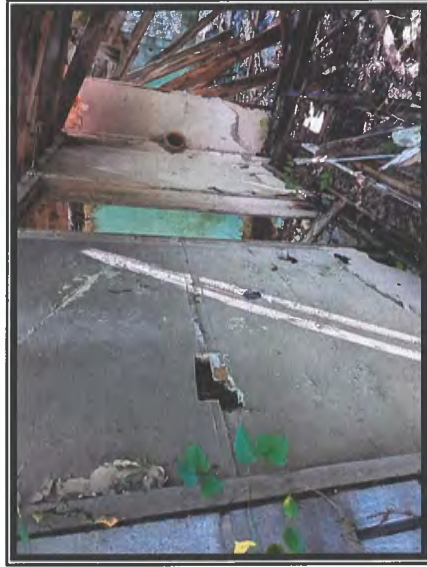
Photo #3
Remnant, Asbestos-containing Sheetrock
Wall Section

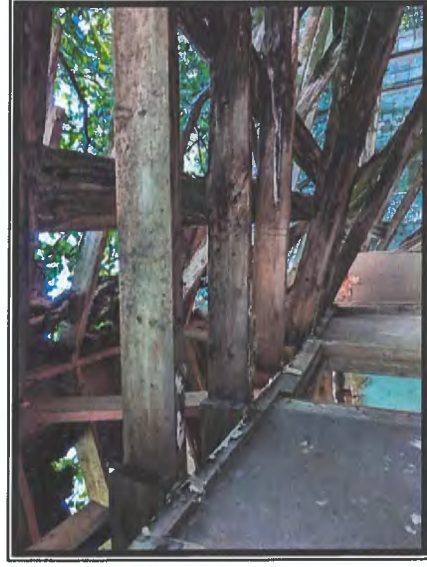
Photo #4
View Depicting Remnant Sheetrock Pieces
on Wooden Ceiling Joists

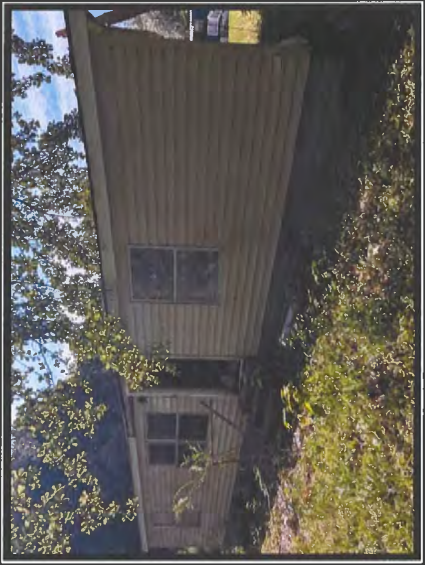
Photo #1
View Depicting the Front of the Mobile Home Unit

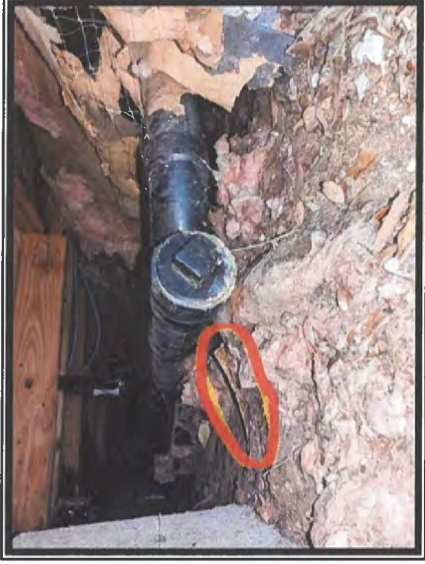
(1) - Asbestos-containing sheet flooring remnants were observed on the ground of the western crawl space area; however, subfloor remnants or sheet sections may have been obscured from view.

Photo #2
View Depicting Asbestos-containing Sheet Flooring Remnant on Ground in Crawl Space

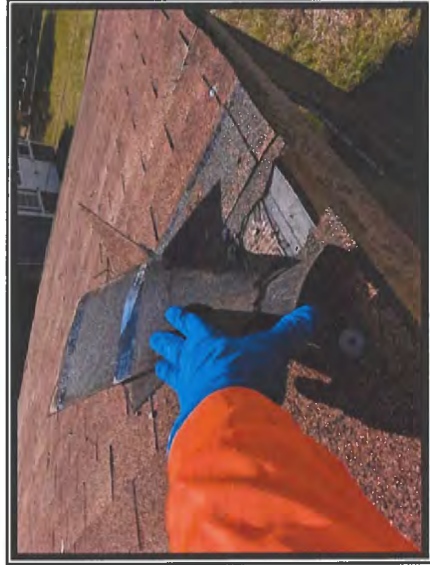
Photo #3
No Asbestos Detected in Roofing Shingles or Felt Layer

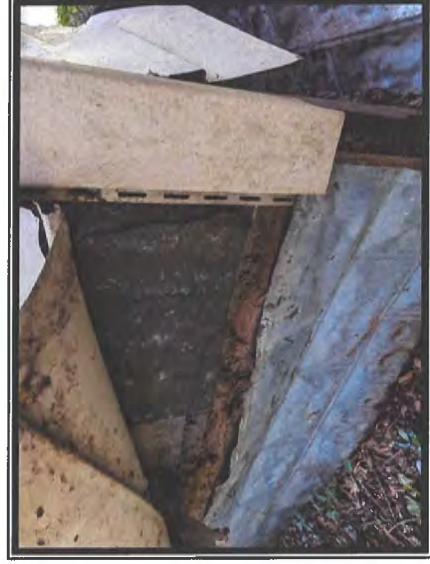
Photo #4
View Depicting Vinyl Wall Cladding over Sheathing Felt and Original Wood Panels

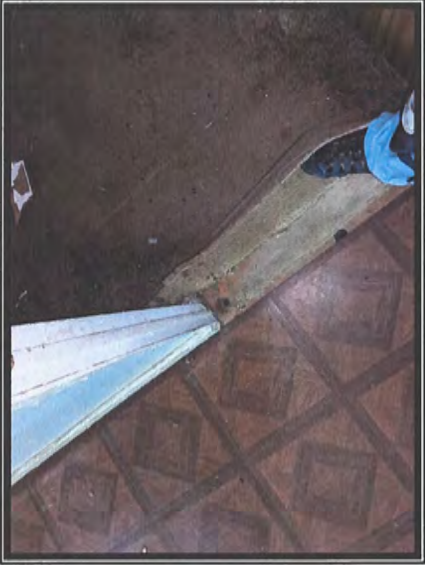
Photo #5
No Asbestos Detected in Any Resilient Flooring
or Carpet Layers

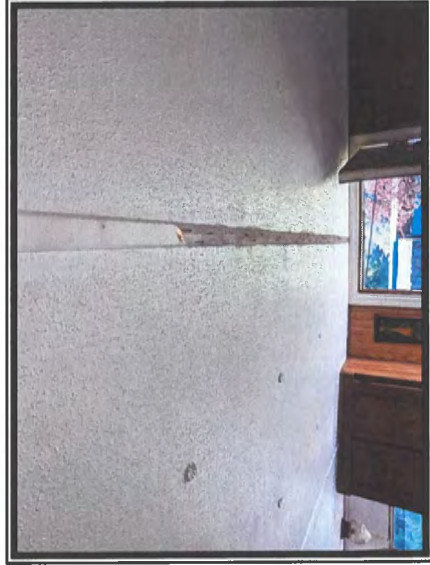
Photo #7
No Asbestos Detected in Gypsum Ceiling
Panels with Simulated Texture

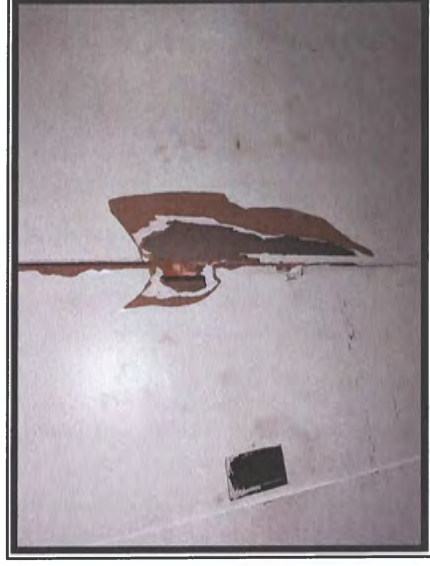
Photo #8
No Asbestos Detected in Gypsum Wallboard
Panels

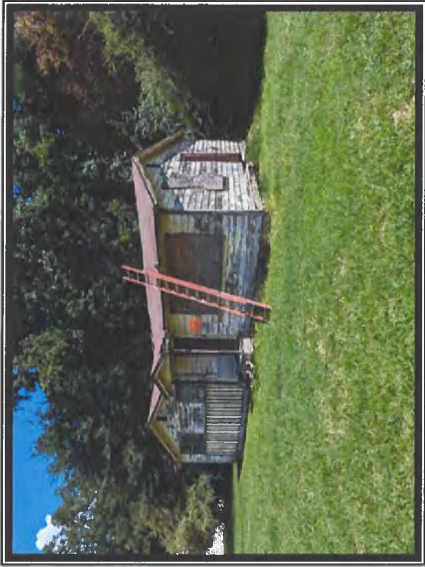
Photo #1
North-facing View of the Residential Structure

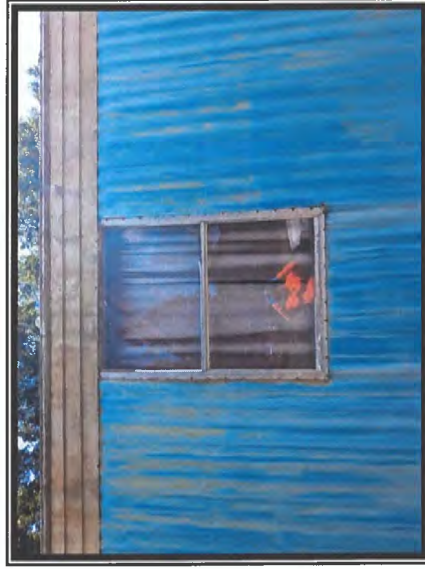
Photo #3
Asbestos Detected at 5% in Caulking
Associated with Exterior Window Frames

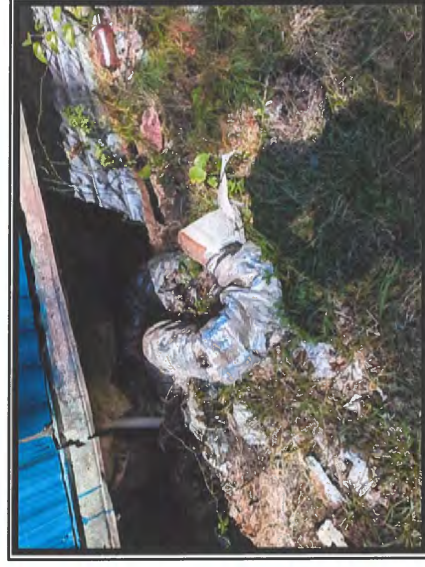
Photo #4
No Asbestos Detected in Duct Tape Associated
with Climate Control Ductwork
