## City of Sumter Design Review Board

## HP-22-13, 210 Church St.

Request: Request for Design Review approval for

construction of a new second floor access stair at

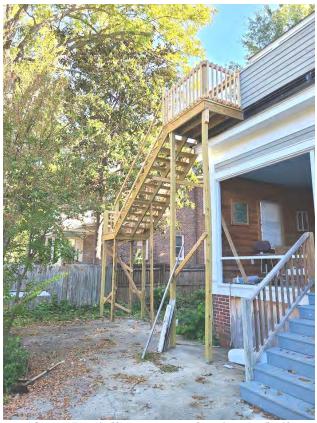
Above: Partially constructed staircase (built without permits), proposed to be removed to the upper landing and reconstructed in configuration as proposed by this application

The current configuration of the staircase constructed prior to the stop-work order appears to conflict with required building setback requirements. As a result, the applicant has submitted a proposed configuration that would preserve the already-constructed second story landing but reconfigure the staircase to exit directly to the rear of the residence and turn at a lower landing 90 degrees before meeting the ground level in the center of the property's rear yard.

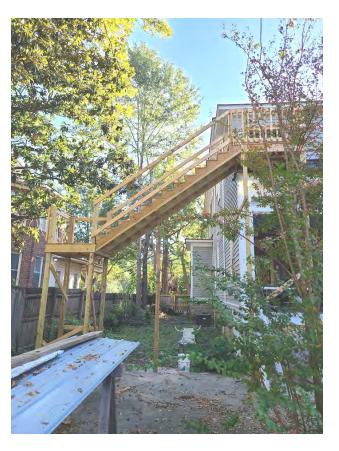
**Above:** Partially constructed staircase as viewed from rear.

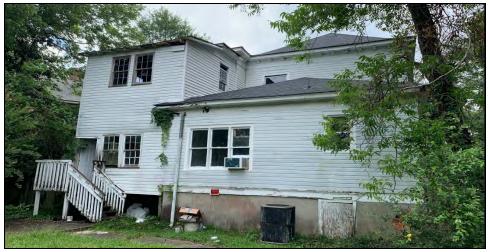
**Above**: rear view of residence prior to alterations approved via HP-19-13 showing previous 1st floor rear access stair configuration and covered  $2^{nd}$  floor addition that has been modified.

The location of the proposed 2<sup>nd</sup> floor exterior staircase was previously occupied by a 1<sup>st</sup> floor exterior staircase and landing. In addition, prior to renovations completed under *HP-19-13*, an internal 2<sup>nd</sup> floor access stair was located inside the 2-story addition. Due to structural deficiencies identified in the addition, the renovations under *HP-19-13* included removal of that access staircase and conversion of the addition to open porch space. While the residence contains at least 1 internal access staircase to the 2<sup>nd</sup> floor, the floor plan of the residence and need for emergency egress does warrant construction of a 2<sup>nd</sup> floor access stair.

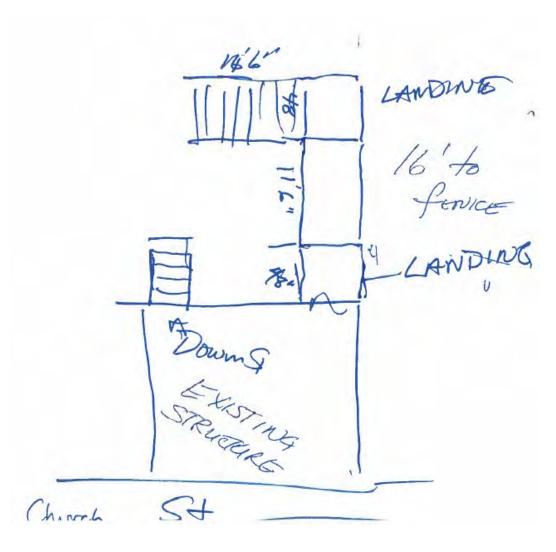
# Proposed 2<sup>nd</sup> Floor Access Stair Configuration and details (submitted by applicant)

The applicant is proposing to use pressure treated exterior-grade natural lumber, with no paint or stain applied.
