REQUEST FOR BIDS
ASBESTOS PROJECT DESIGN, ABATEMENT & AIR MONITORING
ITB# 22-24/25
September 12, 2024

Emerald, Inc. was requested to conduct an Asbestos Survey of the vacant, significantly collapsed, commercial structure located at 5 Harris St. in Sumter, S.C., to identify the presence of any asbestos-containing materials (ACM), prior to demolition activities. The inspection was authorized by Mr. John Macloskie, Codes Director, with the City of Sumter. The inspection included identification and assessment of the condition of suspect asbestos-containing materials, either friable or non-friable, on the interior and exterior portions of the structure.

**Sumter City/County Project:
Dilapidated Commercial Bldg.
5 Harris St., Sumter, SC
-Site Layout**

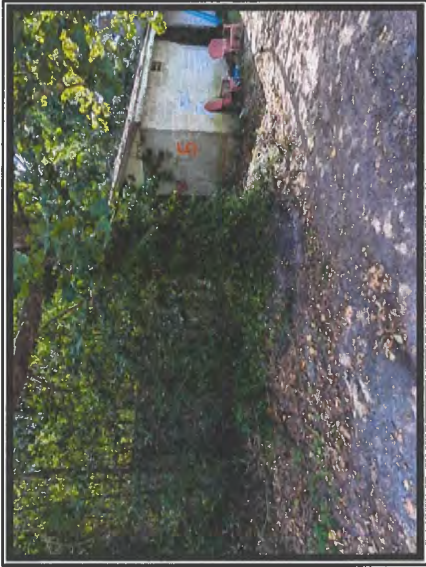
Photo #1
View from Harris St. of the Commercial Bldg. -
East Sect. obscured by Vegetation

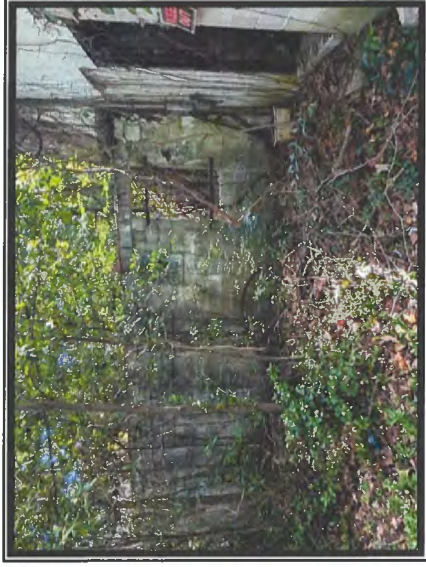
Photo #2
View Depicting the Dilapidated East Section at
the East Front of the Building

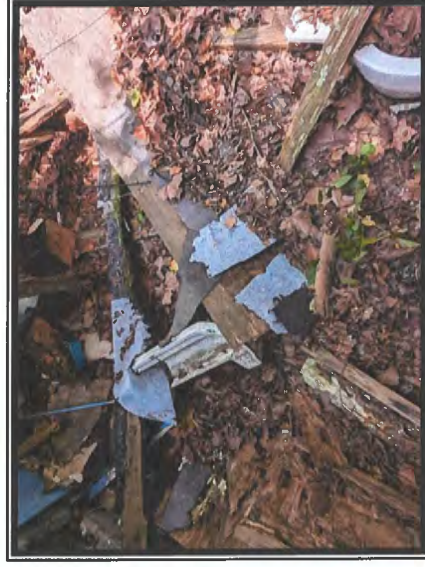
Photo #4
Asbestos-containing Roofing Material in De-
bris Pile of East Section

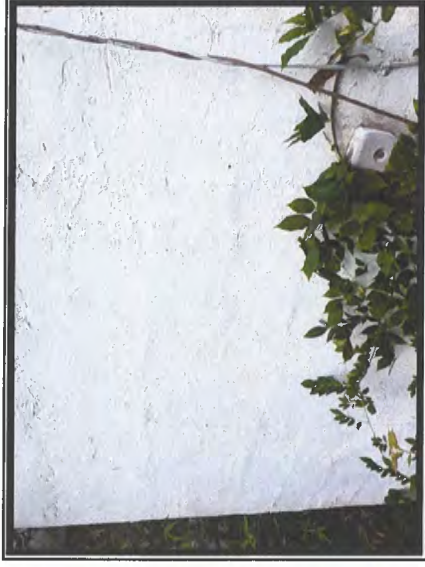
Photo #2
No Asbestos Detected in Exterior Wall Surfacing Material

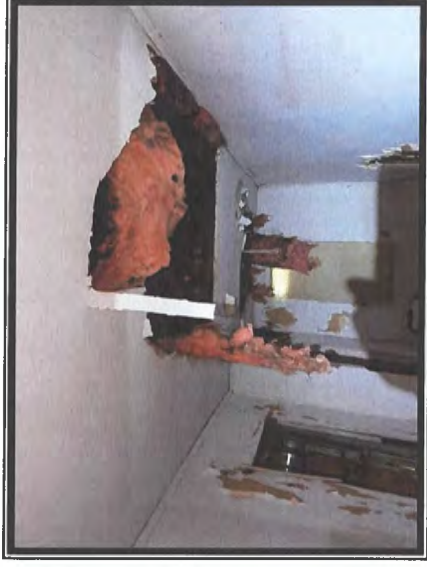
Photo #6
No Asbestos Detected in Sheetrock Ceiling and
Wall System

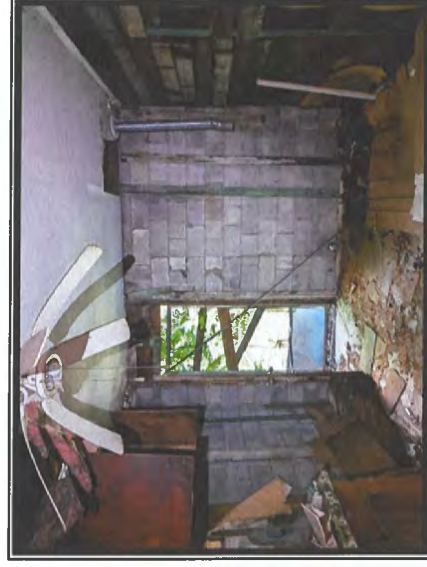
Photo #8
View Depicting CMU Wall Blocks at the Rear of
Room 15D (Kitchen)

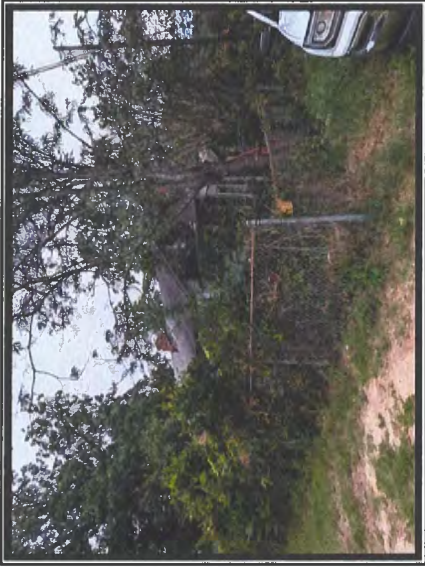
Photo #1
Very Depicting Heavy Vegetation Surrounding the Residential Building

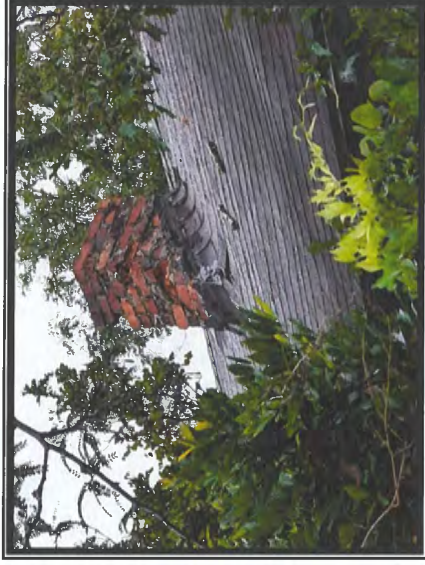
Photo #2
Chimney Sealant Material is Presumed to Contain Asbestos

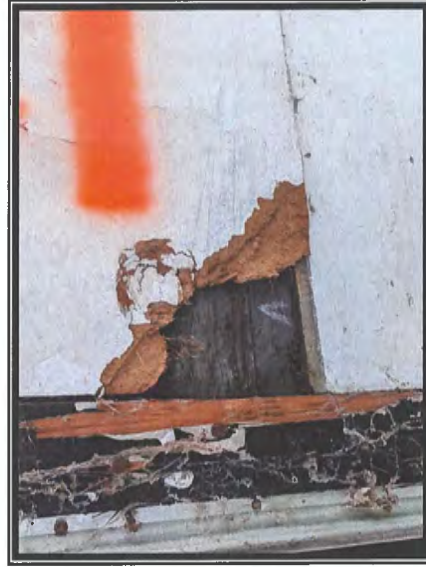
Photo #3
View Depicting Fiberboard Planks over Wood-slat Exterior Siding

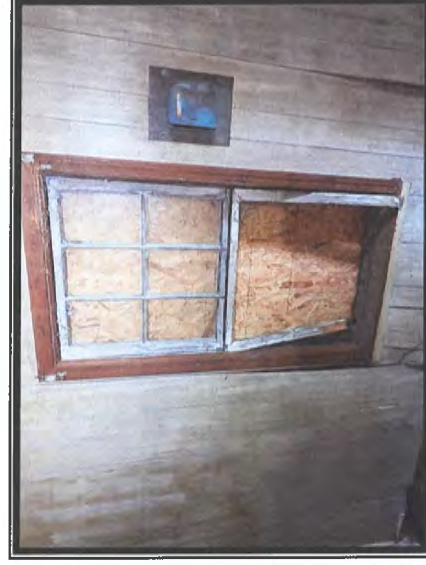
Photo #4
Asbestos Detected at <1% in Window Glaze

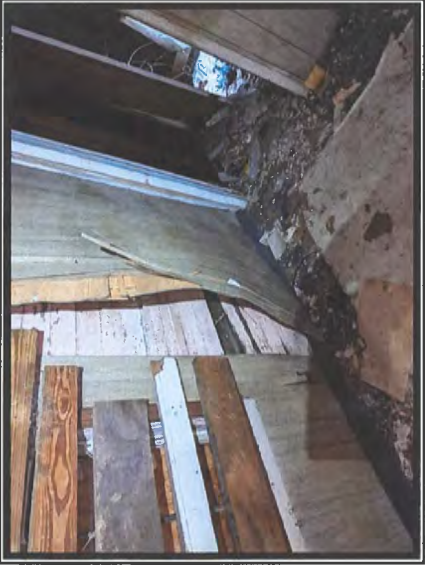
Photo #5
View Depicting Wood Panel and Wood Slat
Interior Walls

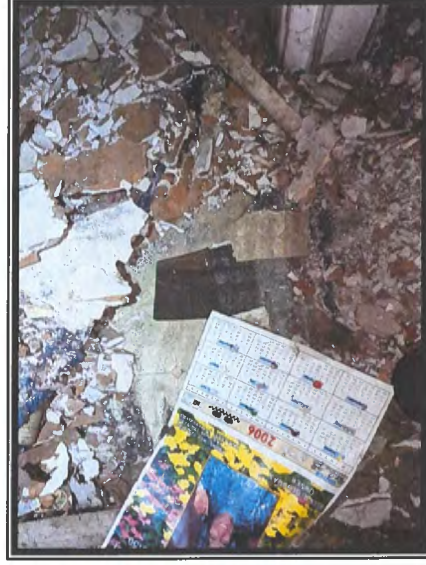
Photo #8
Asbestos Detected at 25% in Bottom-layer
Sheet Flooring in Room 17E

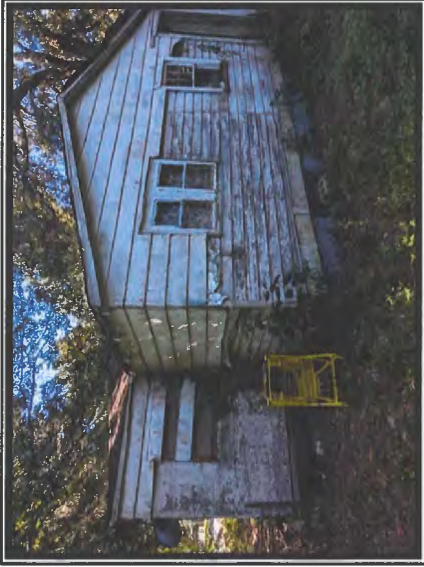
Photo #1
View Depicting Wood Slat and Fiberboard Plank
Exterior Siding

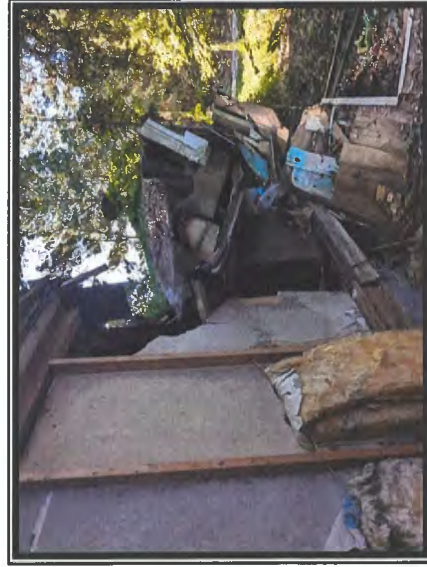
Photo #3
No Asbestos Detected in Sheetrock Wall
Sections (No Joint Compound)

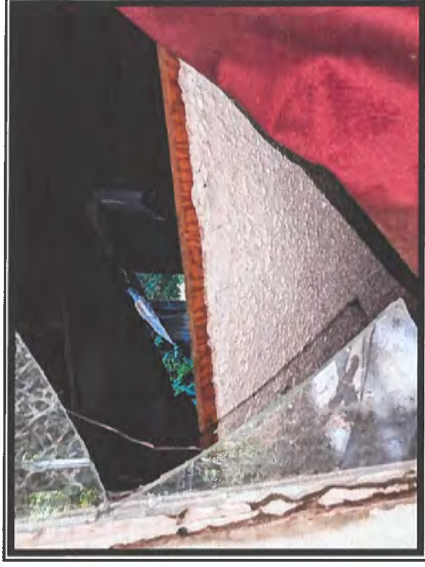
Photo #6
View Depicting Plywood Ceiling Panel with
Spray-applied Texture

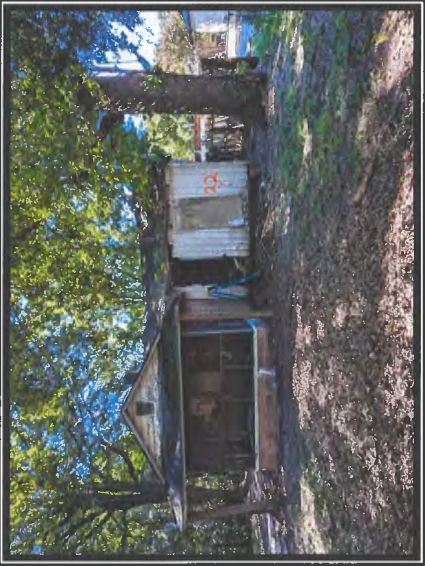
Photo #1
South-facing View Depicting the Front of the Residential Structure

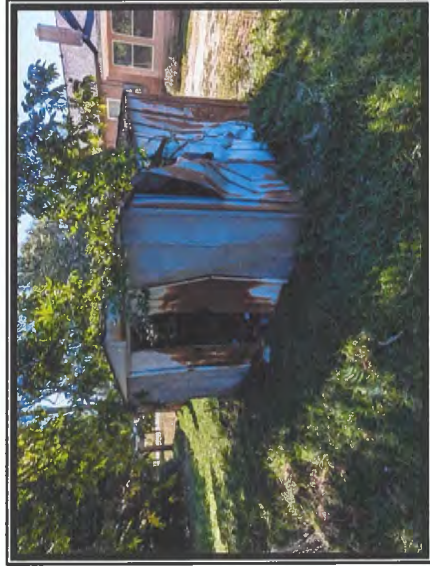
Photo #3
No Suspect Materials Associated with a Standalone, Metal Shed Unit

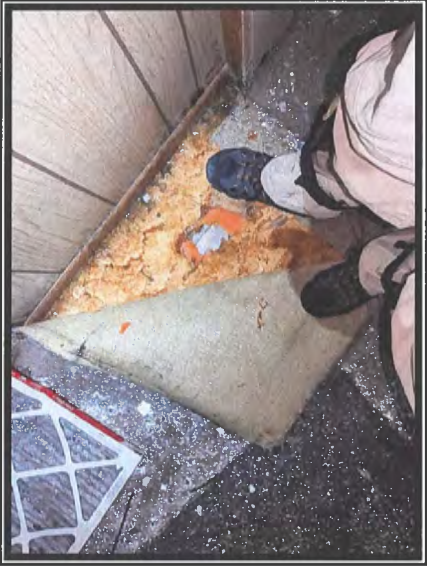
Photo #9
No Asbestos Detected in Carpet Materials

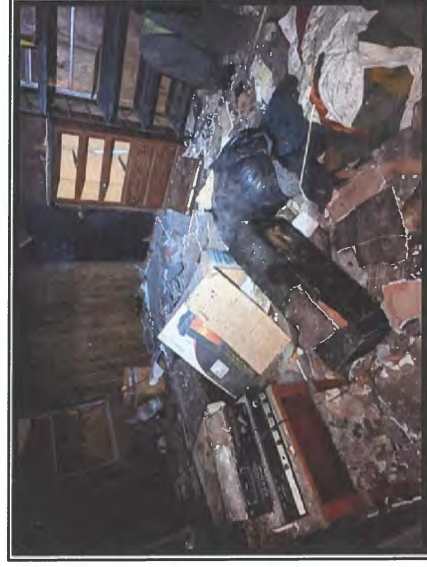
Photo #12
View Depicting the Interior of Room 22F in the Addition Section

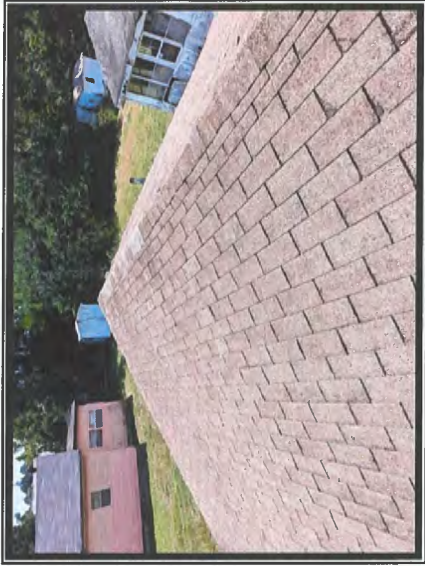
Photo #6
No Asbestos Detected in Roofing Shingles or Associated Felt Material

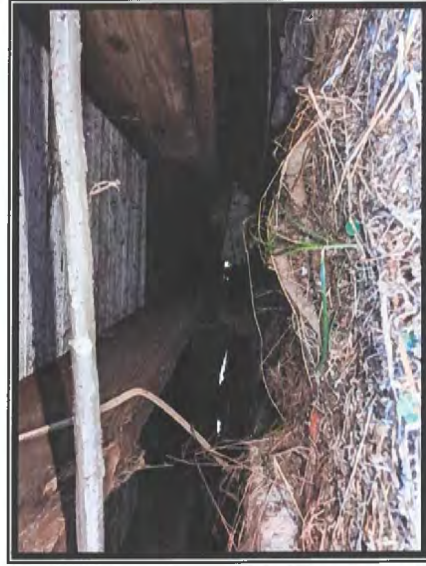
Photo #8
No Suspect Materials Associated with the Crawl Space Area

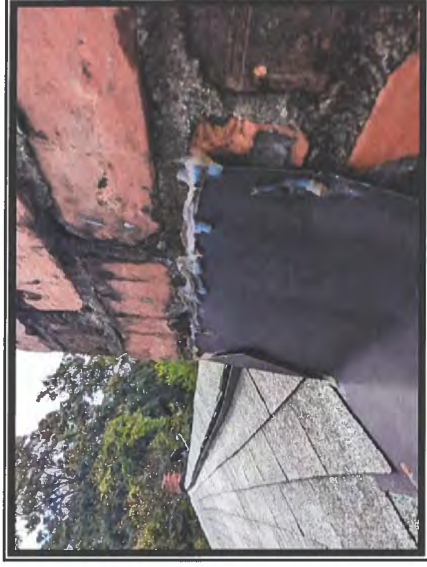
Photo #2

No Asbestos Detected in Chimney Material or Roof Coverings of the Residential Bldg.

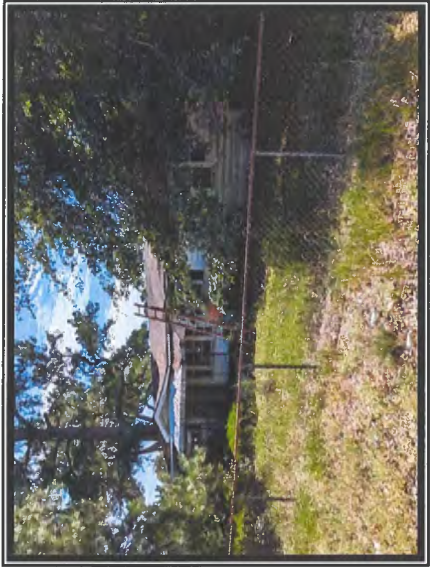
Photo #1
South-facing View of the Residential Structure

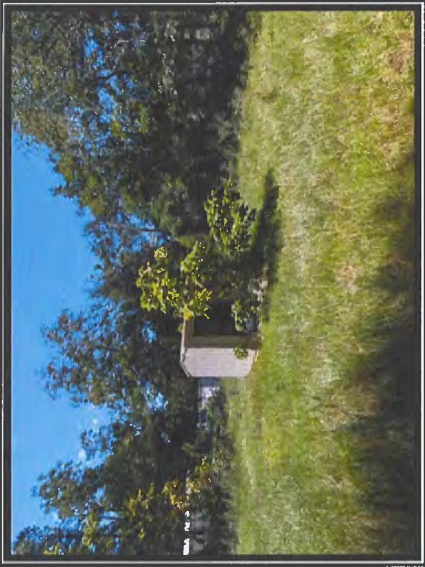
Photo #5
No Suspect Materials Associated with Standalone Metal Storage Shed

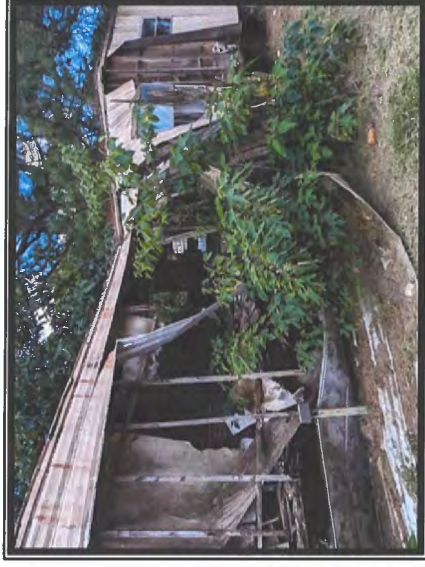
Photo #2
North-facing View Depicting the Significantly Dilapidated State of the Mobile Home Unit

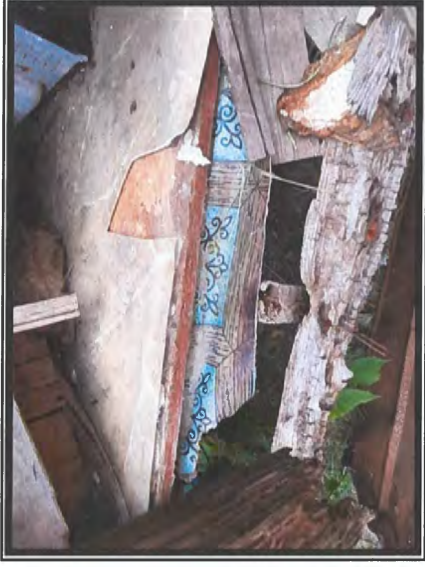
Photo #6
No Asbestos Detected in Tan-colored or Green
and Brown-colored Sheet Flooring

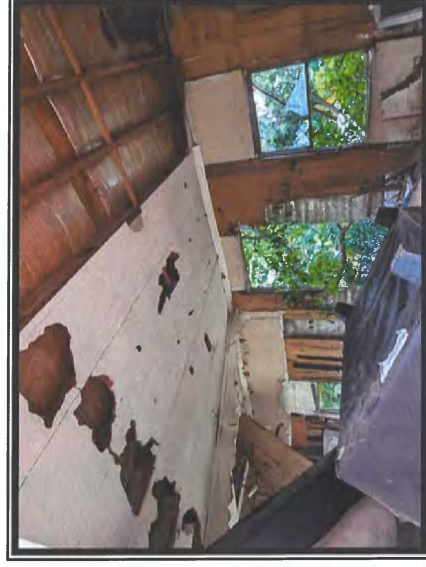
Photo #8
No Asbestos Detected in Ceiling Panels with
Textured Surface

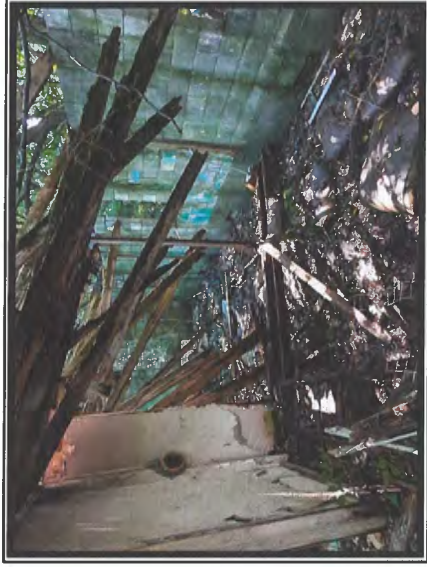
Photo #6

View Depicting Debris Pile with Asbestos-containing Sheetrock and Roofing

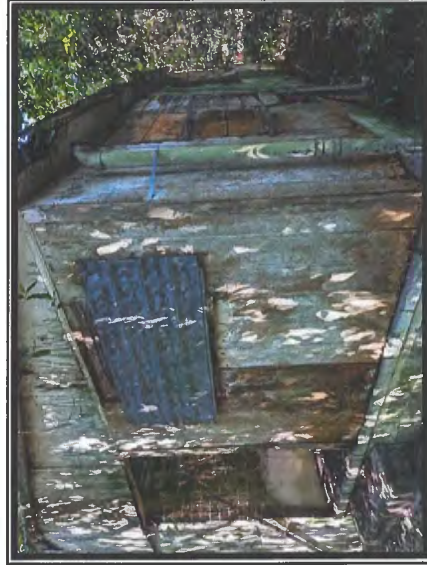
Photo #7

View Depicting Wood-framed and Sided Section at the Rear of the Building

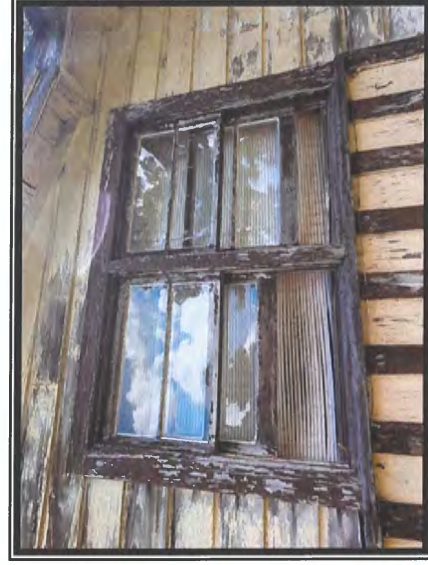
Photo #4
No Asbestos Detected in Window Glaze

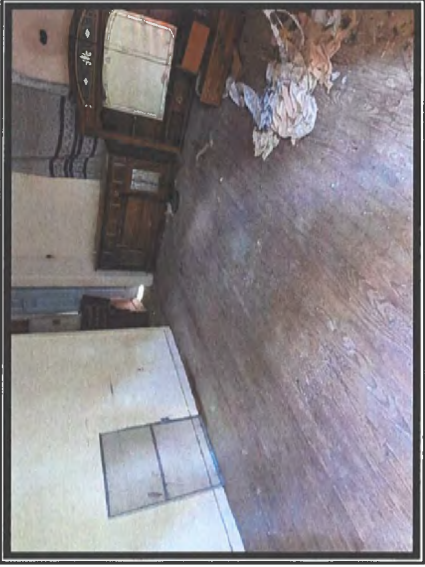
Photo #5
View Depicting Uncovered, Hardwood Floors

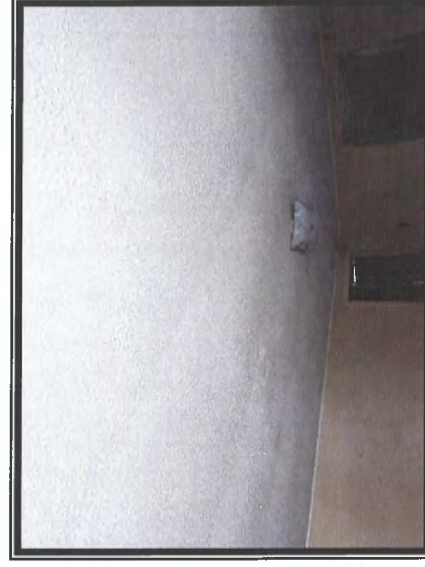
Photo #8
No Asbestos Detected in Spray-applied Ceiling Texture

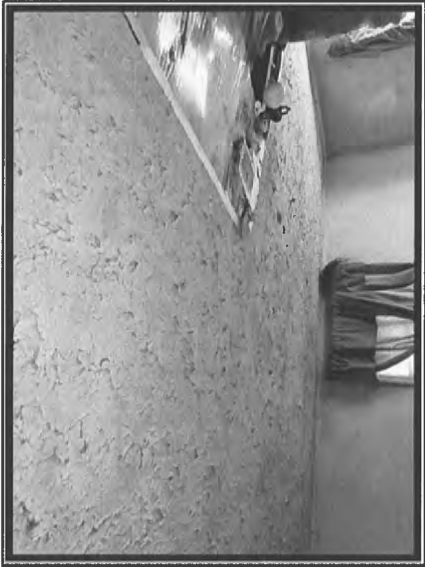
Photo #5

Asbestos Detected at 3% in Ceiling Sheet-rock System & at 2% in Stippled Texture

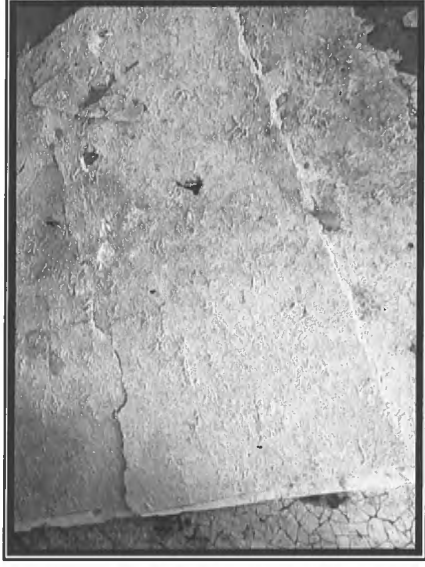
Photo #6

View Depicting Asbestos-containing Sheet-rock w/ Stippled Texture on the Floor

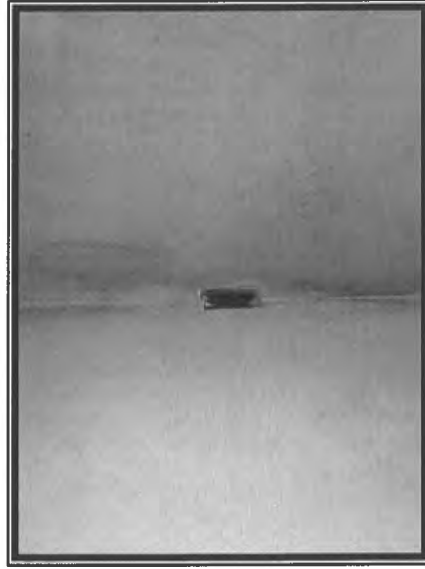
Photo #7

Asbestos Detected at 3% in Sheetrock Wall System of Room 1561F

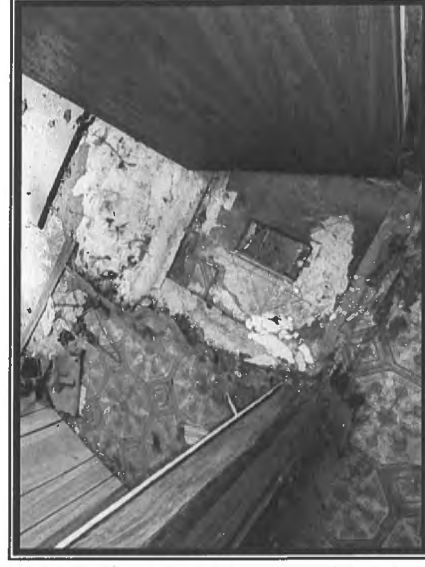
Photo #8

No Asbestos Detected in Any Flooring Layers
